Spy in the Sky: Aerial Thermal Imaging for Community- Based EE

Erin Buchanan, Cedar Falls Utilities
February 8, 2012

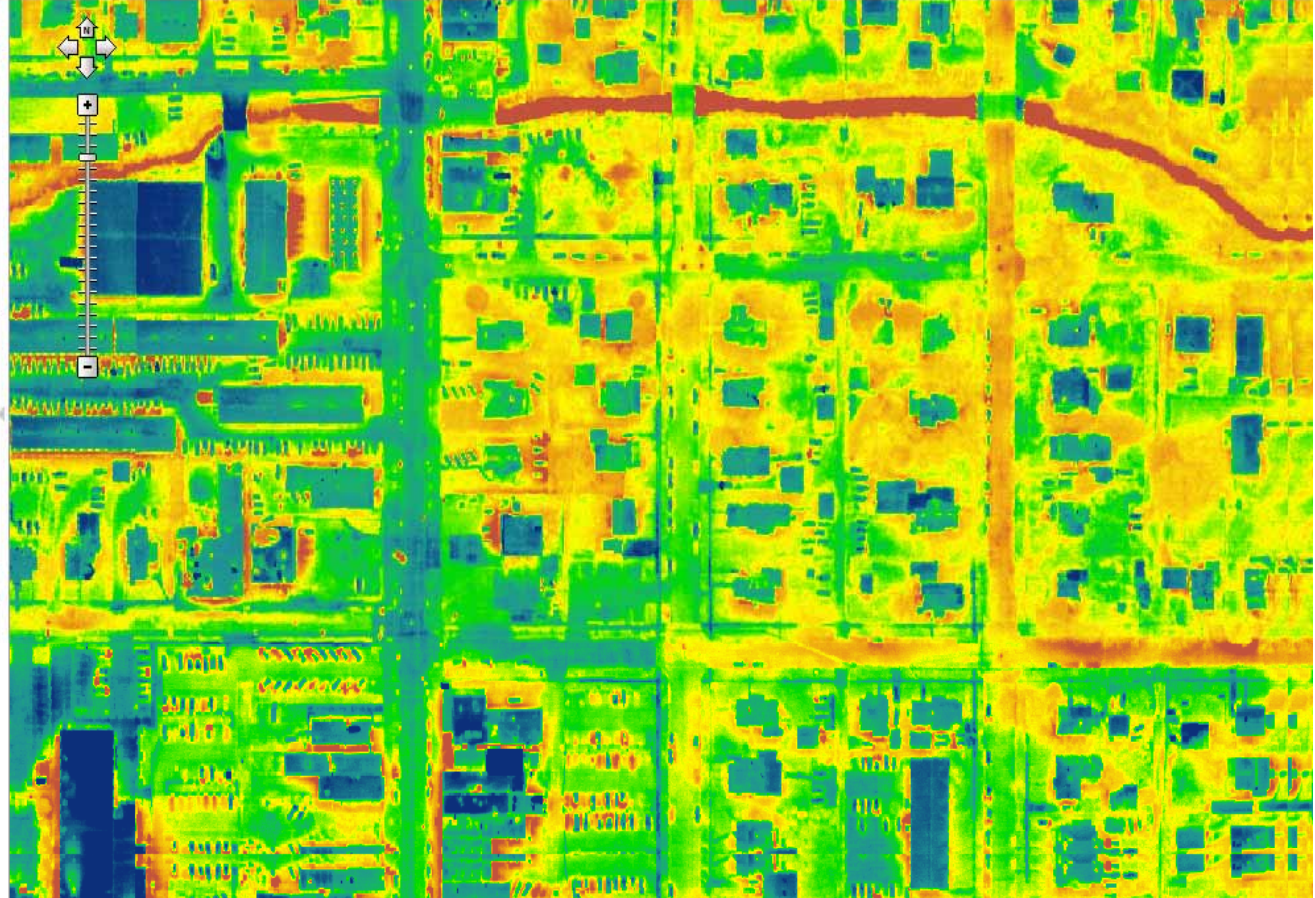
Public Map & Address Search

Aerial Thermal Image for Cedar Falls, IA

Hot. High heat loss
-

Warm. Heat loss likely
-

Warm. Potential heat loss
-

Cold. Good insulation

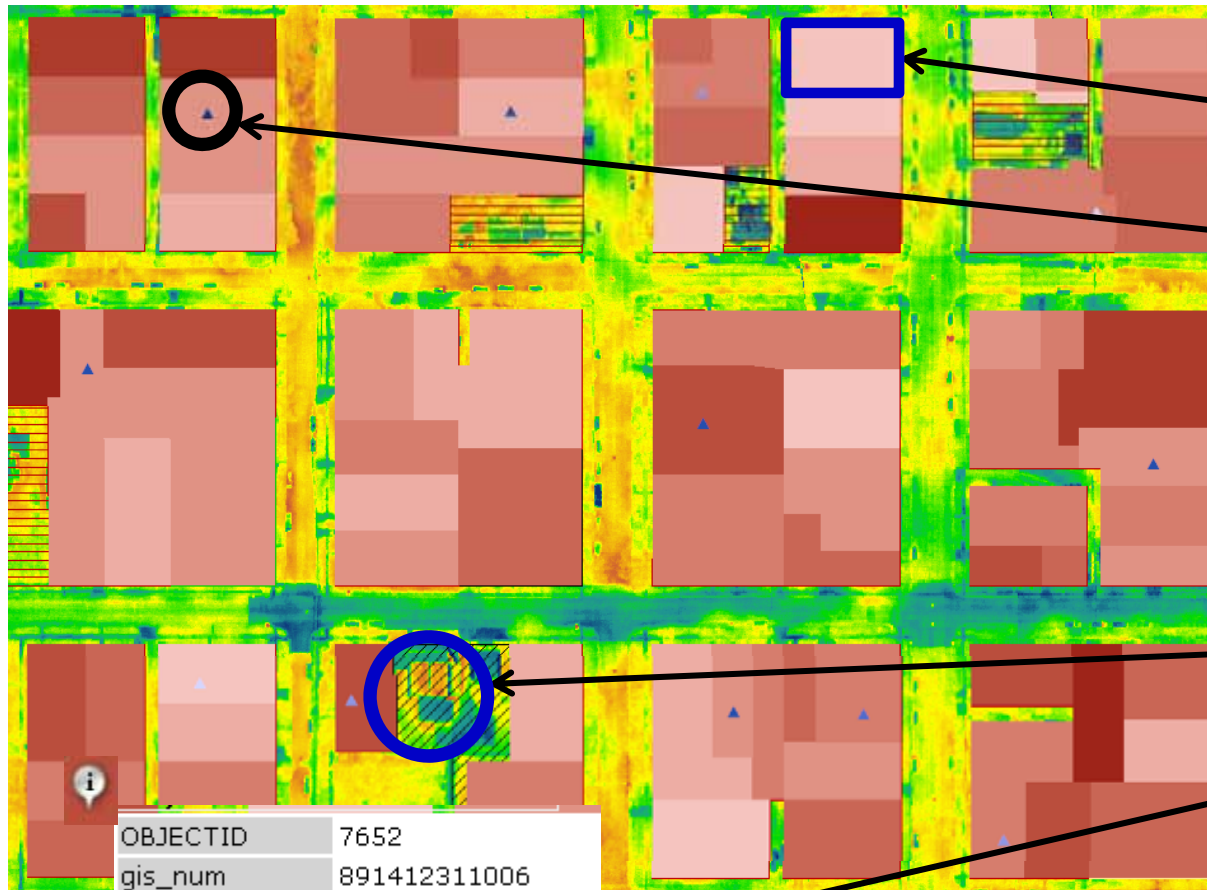
CFU Internal GIS Map Data

In addition to thermal image:

2010 kBtu/ft²

R-values from
prior audits &
insulation
projects

Roof material

Year built

OBJECTID	7652
gis_num	891412311006
descr	Asph / Gable
comstoryhe	0
comyearbui	1894

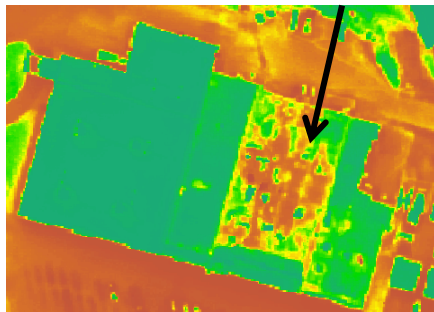
Moisture damaged roof

Qualitative: Identification of several basic EE problems:

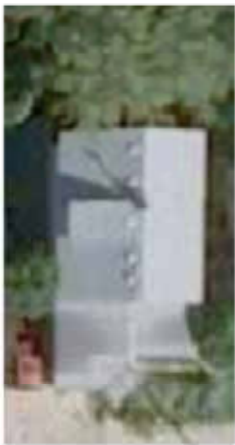
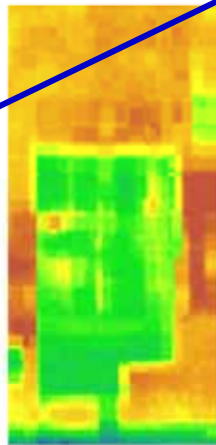
Below is a copy of your daylight image (taken mid-2009) and thermal image (taken November 2010):

Aerial view

Thermal view
